# Structural Analysis Comparison

GRANITE AND PRECAST CURBING

Prepared by Department of Civil Engineering  
**UNIVERSITY OF MASSACHUSETTS  
AT AMHURST**

January 1991

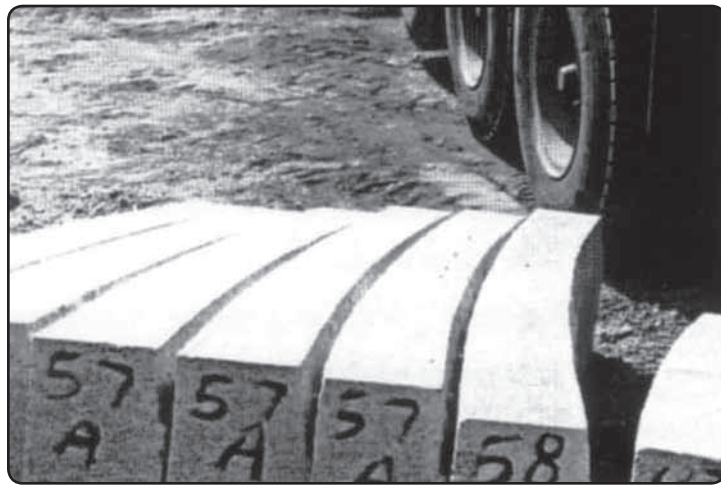
FIGURE 1: Standardized granite vertical curb (radius).

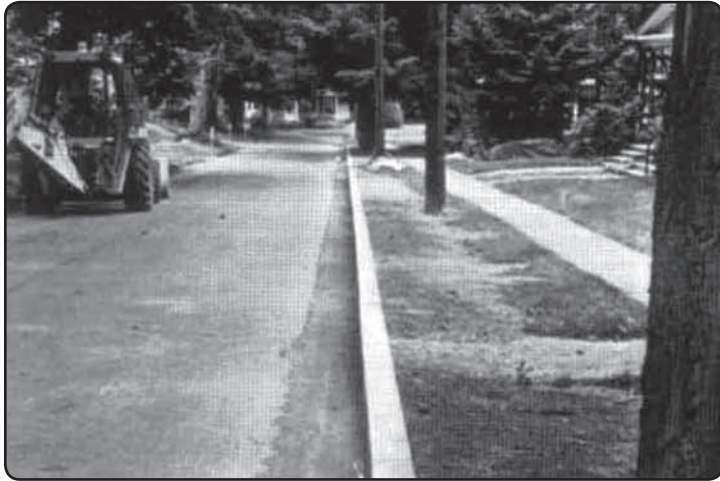
FIGURE 3: Modern machinery and methods produce granite curbs with neatly sawn tops and smooth split faces, adding to the aesthetic appearance of pavement.

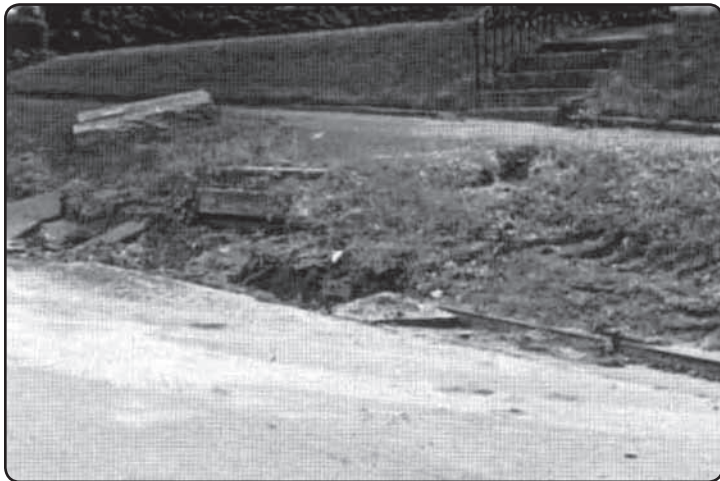
FIGURE 4: Due to its long life span, granite curb can be removed and reset to a new line or grade.

Considering the recycling of curbing material, most highway construction specifications call for granite as a curbing material where salvaging and reuse during highway widening and construction are considered.

Reuse of granite is enhanced as it can be cut into different widths and shapes (5). Granite also is used as a facing for precast concrete curbs (8).

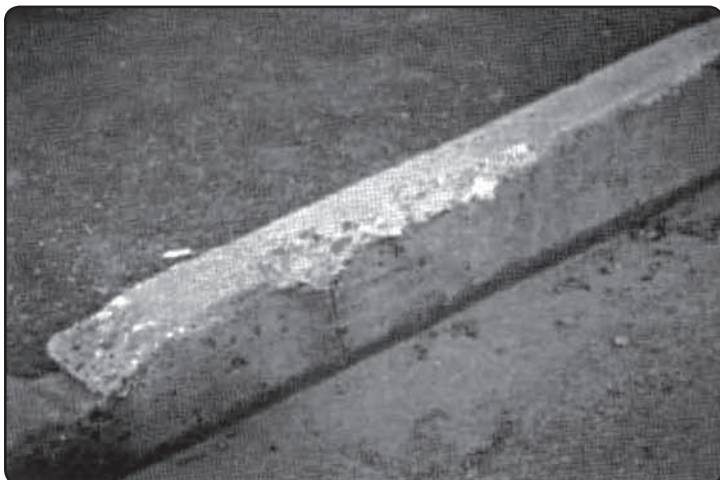
FIGURE 5: Concrete in the long run is susceptible to problems such as spalling.

PCC curb, however, deteriorates over time. Deterioration generally occurs at a greater rate along the back of the curb. This is due to the availability of moisture against this face. The back of the curb, which has less opportunity to dry off, is saturated during more freeze/thaw cycles than the front. The result of this deterioration is that the curb's appearance may conceal its true condition. When weakened curb is subjected to an impact, the collapse is sudden and complete.

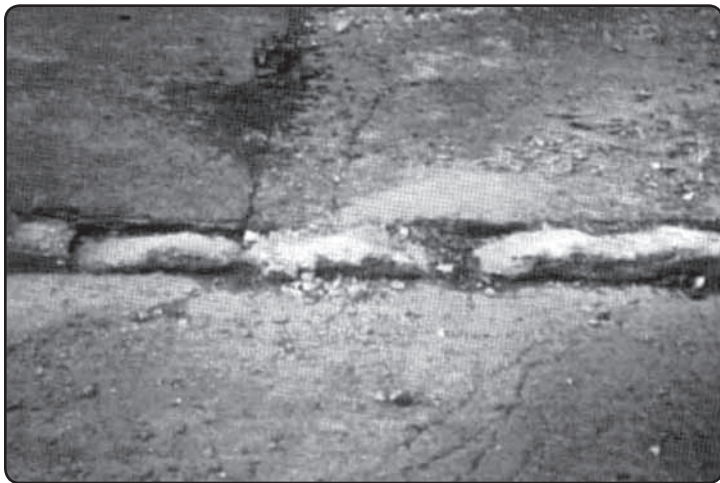
FIGURE 7: View of a completely deteriorated concrete curb.

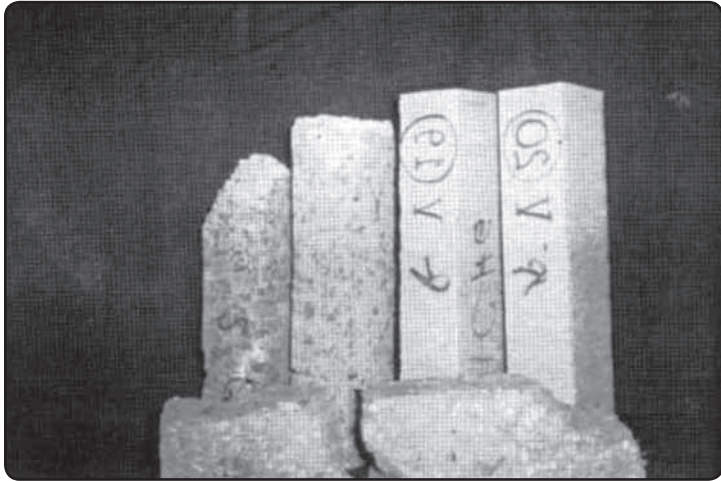
FIGURE 9: New granite and new precast concrete samples subjected to freeze/thaw testing.

Durability under climatic conditions may be assessed by considering strength changes during weathering, with the most serious being the mechanical weathering associated with freeze/thaw and de-icing salts. Freeze/thaw cycles contribute to both reduction in strength and surface scaling in concrete (2). Recent studies on concrete and granite curbing (3) indicate that both granite and concrete test specimens endured 450 freeze/thaw cycles. However, no change occurred in the appearance of the granite compared to the concrete that showed sharp deterioration in appearance; particularly the corners and edges that were rounded as a result of spalling. The modulus of the concrete determined by sonic measures decreased to zero while that of the granite retained half of the original value.

Laboratory determination of durability characteristics related to tensile strengths of granite and precast PCC showed a reduction of tensile strength by freeze/thaw cycles. The lowest flexure modulus of granite (397 psi) was found to be 15% higher than the highest precast PCC flexure modulus (357 psi) after 450 freeze/thaw cycles. It can be deduced that if PCC curbing's strength decreases for any reason then it could become inadequate to withstand impacts.
