American Granite Curb Producers

The American Granite Curb Producers announce the results of the most exhaustive tests and analyses ever performed, providing an unbiased comparison of the properties of granite and precast concrete curb.

The civil engineering department of the University of Massachusetts has published the results of a joint study conducted with the University of Connecticut and commissioned by the American Granite Curb Producers. The report, A Comparative Analysis of Granite and Precast Concrete Curbing, states the results of comprehensive testing and analysis conducted to determine the relative merits of granite and precast Portland cement concrete curbing. Economic factors, as well as physical characteristics, were carefully examined and documented.

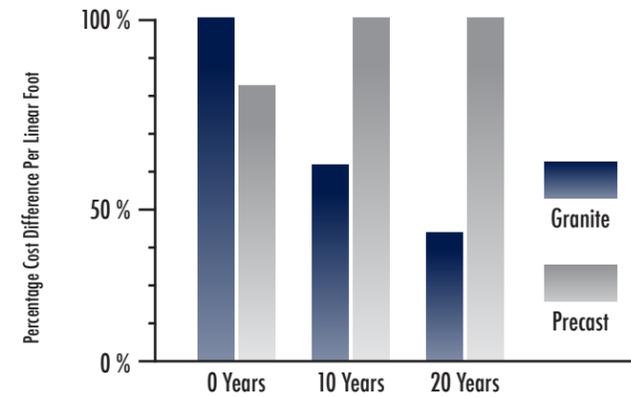
Graphic comparison of 20-year period

GRANITE VS PRECAST CONCRETE

The above chart demonstrates total cost comparisons of granite and precast curb over a twenty year period assuming precast is replaced at year ten. Both initial and recurring costs were considered. Replacement of precast curb at year twenty is not included. Detailed charts and discussions of the effect of NPV's are contained in the study.

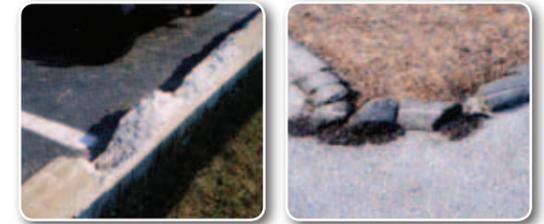
Concrete curb cannot survive even a short period if it is not backed up by soil. Berm always fails the snowplow test.

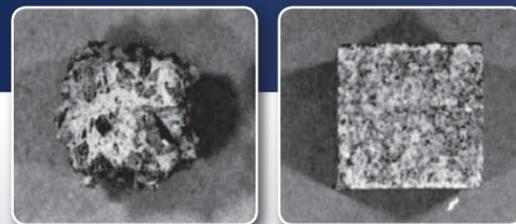
Concrete (left) and granite (right) were subjected to ammonium nitrate immersion tests. After 40 cycles, concrete lost 50% of its weight - granite lost none.

Chemical de-icing agents used on roads can affect the durability characteristics of both concrete and granite, causing weight loss in curbing materials. Immersion of concrete in various salt solutions was accompanied by a reduction in strength of 25.1% to 74.4%. Reduction in granite was from 0 to 3.41%. De-icing salts also can cause weight loss in curbing materials. Cyclic salt immersion and drying caused extensive surface scaling in concrete curb, and up to 160 times more weight loss. The effect on granite was negligible. The tests established that granite is significantly stronger and far more resistant to weathering than concrete curb. It also can withstand road milling, a commonly used resurfacing technique.

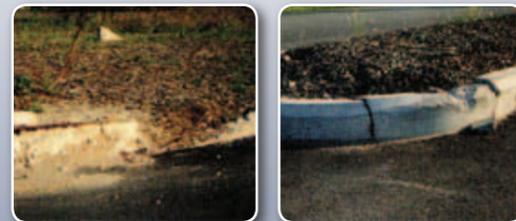
The effects of impact are obvious in these examples of precast curb installed less than three years ago.

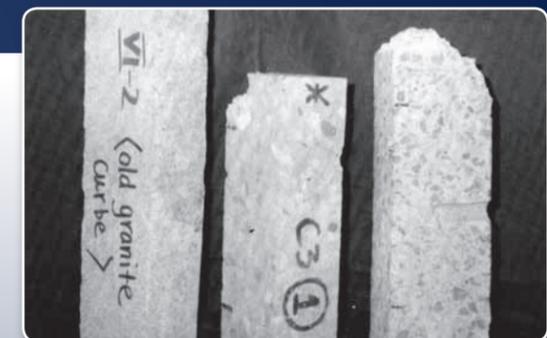
80-year-old granite curb (left) was compared with precast concrete (center and right) in freeze/thaw tests. The granite was totally unaffected after 450 freeze/thaw cycles. Concrete showed considerable deterioration.

The two most significant climatic factors that affect curbing are freezing and thawing. In the tests, both granite and concrete curb were subjected to 360 freeze/thaw cycles. Although no change in appearance of the granite was apparent as result of the freeze/thaw cycles, the concrete exhibited a marked deterioration. This was particularly apparent on corners and edges that were rounded as a result of spalling. Results of the tests indicate that concrete curb will show distress and deterioration after five years in regions that experience around 75 or more freeze/thaw cycles.
